Management and Maintenance Manual  
The Old Hospital Complex  
Fort Carson, Colorado  
(5EP1778)

James Schneck

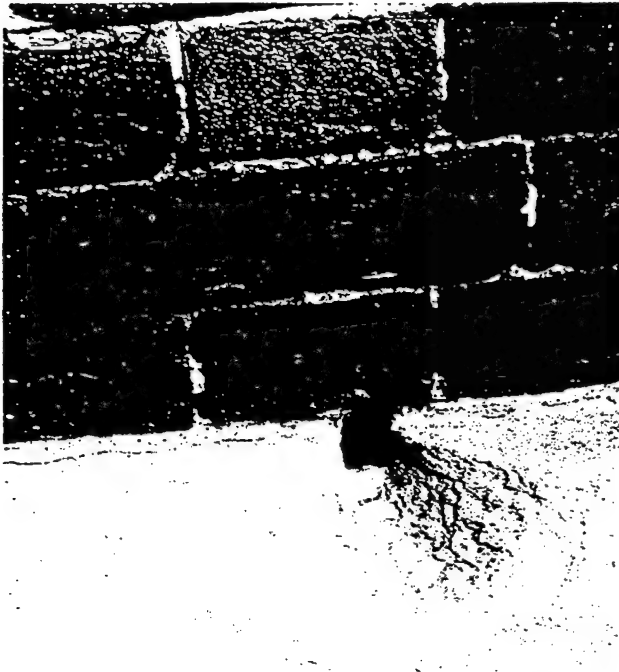
*Figure 1. The iron anchor shown here originally was hidden from view. An increase in volume due to rusting created internal pressures on the stone and brick, causing spalling. Careful study of the building construction can result in the identification of these potential problem areas and they can be taken into consideration while planning a cleaning project.*

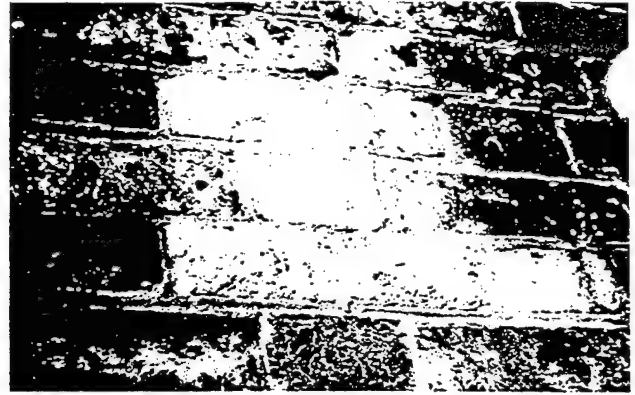
*Figure 2. The white deposits are efflorescence, soluble salts deposited on the surface of the masonry. These salts usually originate in the masonry or mortar, migrate from the ground below through capillary action, or are brought in by air pollution. The salts also may be the result of chemical reactions resulting from selection of an improper cleaner.*

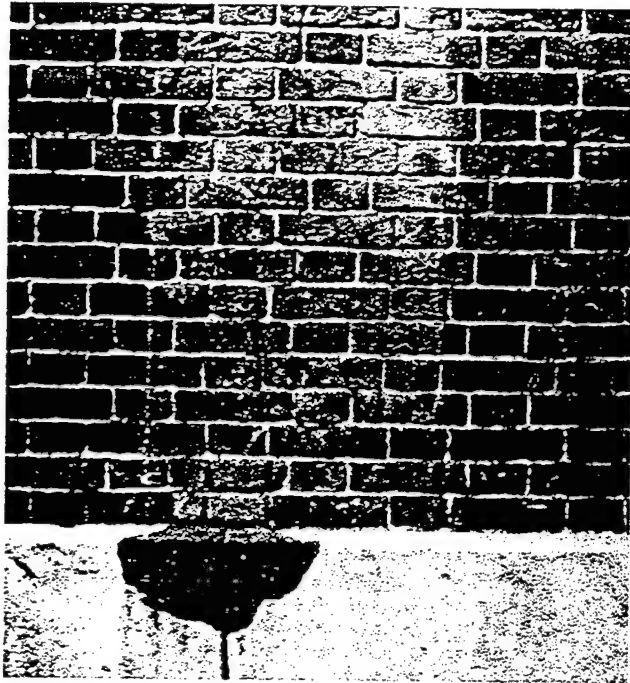
Figure 3. The hazy appearance of a portion of the brick is caused by a residue resulting from cleaning. This film occurred in spite of thorough rinsing. Test patches such as this should always be allowed to weather prior to continuing with the cleaning.

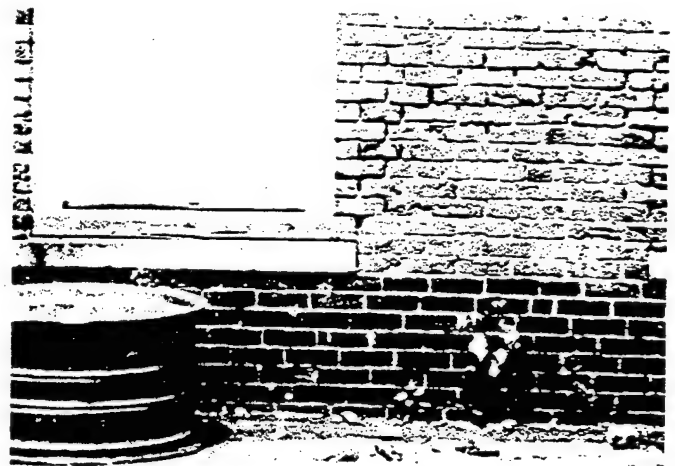
Figure 1. All buildings and building materials are in a constant process of deterioration, such as the brick masonry seen here. Through repointing, the deteriorated mortar joints which might otherwise lead to serious damage, can be renewed and thus preserve the historic character and integrity of the brickwork. Photo: Baird M. Smith.

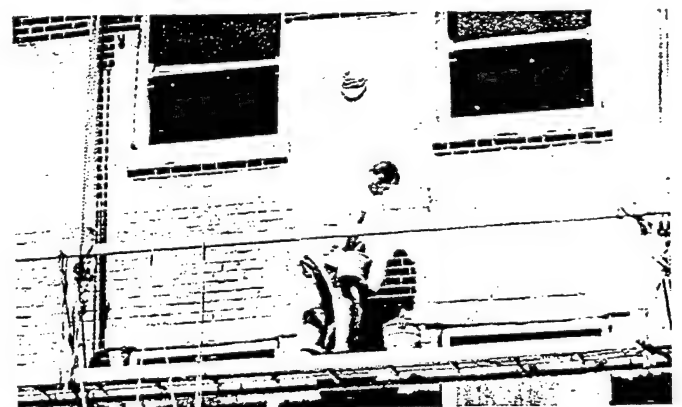
Figure 7. This photograph shows the significant visual change which can result from improper repointing procedures. Note the increased thickness of the joints, the color variation, and the difference in the method of tooling—all noticeable even from a distance. Photo: Ler Nelson.

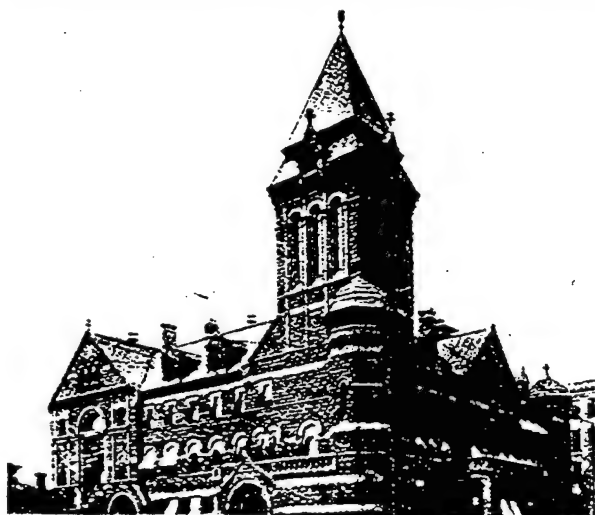
Figure 1. This 1891 Courthouse and Post Office in Rochester, New York, has built-in energy conserving features such as, heavy masonry walls, operable windows, an interior skylighted atrium which provides light and ventilation, and roof-top ventilators which keep the building cooler in the summer. Also note the presence of awnings in this old photograph.

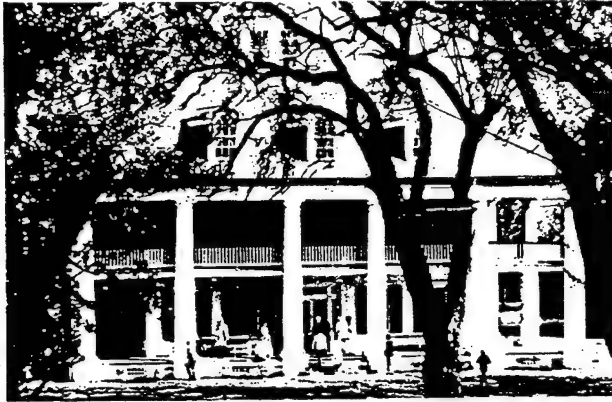
Figure 3. Southern mansions typify climate conscious design. The wide roof overhangs, exterior porches, shade trees, heavy masonry walls (painted white), and living quarters on the second floor (to catch evening breezes and escape the radiant heat from the earth's surface) all are energy saving characteristics which provide reasonably comfortable living spaces without mechanical air conditioning. (Photo: Marcia Axtmann Smith)

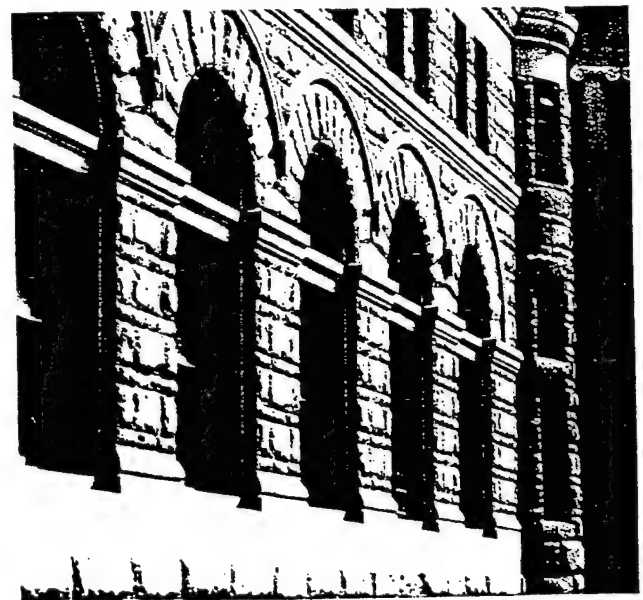
Figure 4. Heavy masonry walls in office buildings dramatically reduce the need for summer cooling because the thermal inertia (M factor) of the massive wall increases its thermal resistance (R factor), thus delaying the heat transfer into the building until late afternoon when the office workers have gone home. (Photo: Baird Smith)

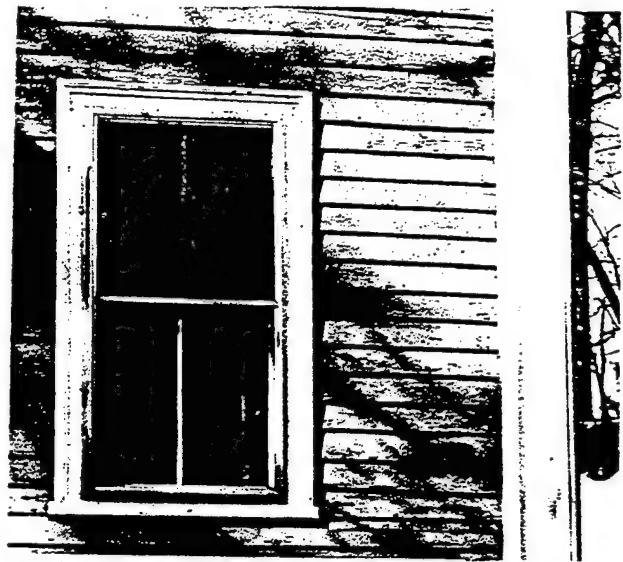
Figure 6. The addition of triple track storm windows, as shown here, greatly improves the thermal performance of existing window assemblies, with a minimal impact on the appearance of the building. (Photo: Baird Smith)

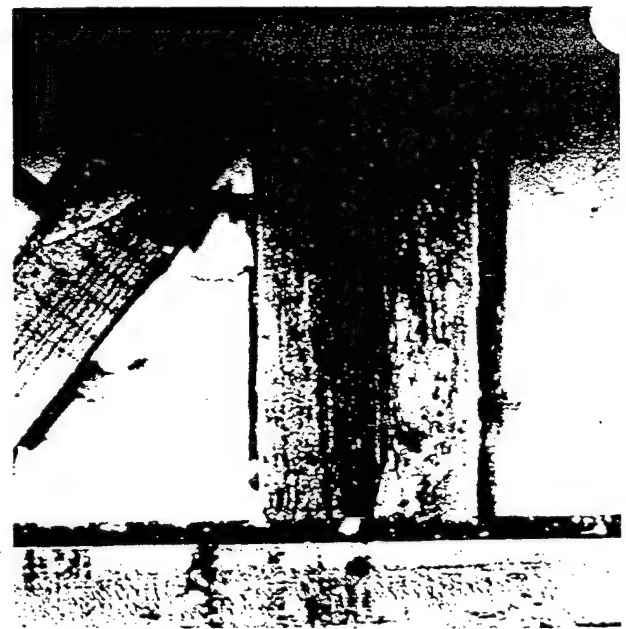
Figure 8. The white material seen between the wooden wall studs is urea-formaldehyde foam. It is injected into the wall cavity wet, and as it cures, large quantities of moisture are given off creating the potential for serious deterioration of adjacent materials and may cause paint to blister on interior and exterior wall surfaces. Additionally, foam can shrink as much as that shown here (about 7% by volume), thus reducing the predicted insulating performance. Until some of the technical problems are corrected, its use is not recommended in historic structures. (Photo: B. Smith)

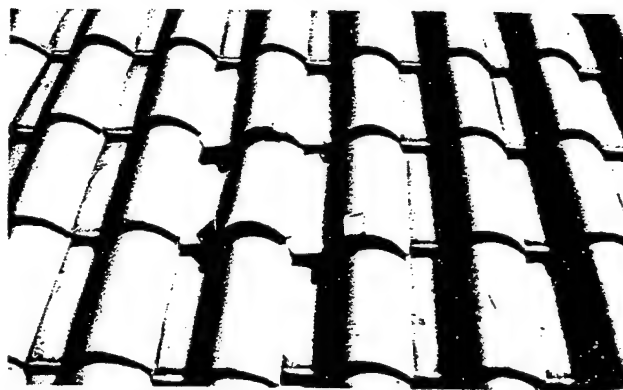
*Repairs on this pantile roof were made with new tiles held in place with metal hangers. (Main Building, Ellis Island, New York)*

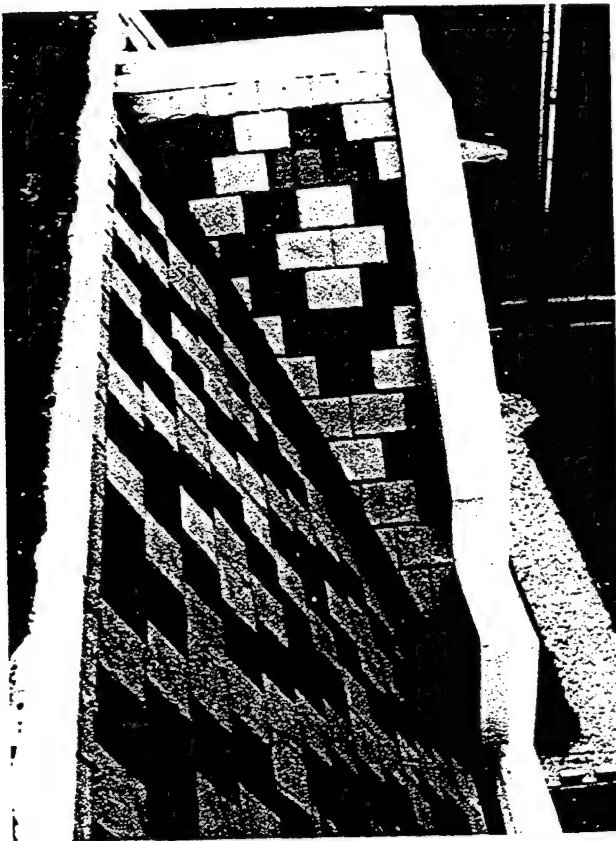
*The Victorians loved to use different colored slates to create decorative patterns on their roofs, an effect which cannot be easily duplicated by substitute materials. Before any repair work on a roof such as this, the slate sizes, colors, and position of the patterning should be carefully recorded to assure proper replacement. (Ebenezer Maxwell Mansion, Philadelphia, Pennsylvania, photo courtesy of William D. Hershey)*

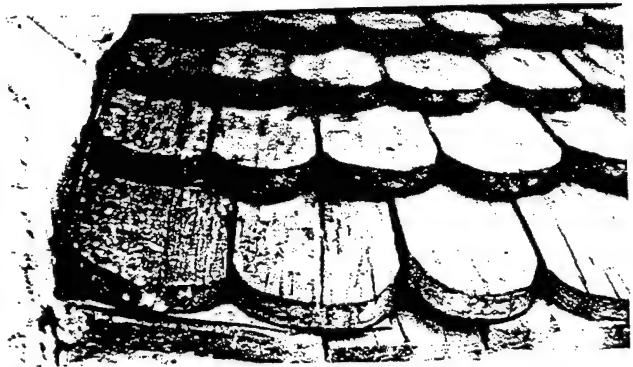
*Replacement of particular historic details is important to the individual historic character of a roof, such as the treatment at the eaves of this rounded butt wood shingle roof. Also note that the surface of the roof was carefully sloped to drain water away from the side of the dormer. In the restoration, this function was augmented with the addition of carefully concealed modern metal flashing. (Mount Vernon, Virginia)*

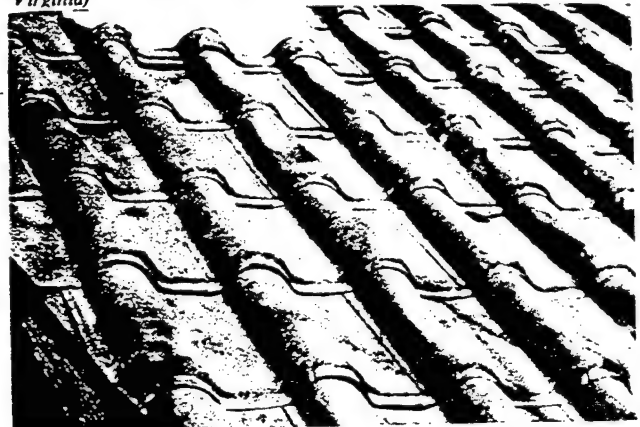
*Galvanized sheet-metal shingles imitating the appearance of pantiles remained popular from the second half of the 19th century into the 20th century. (Episcopal Church, now the Jerome Historical Society Building, Jerome, Arizona, 1927)*

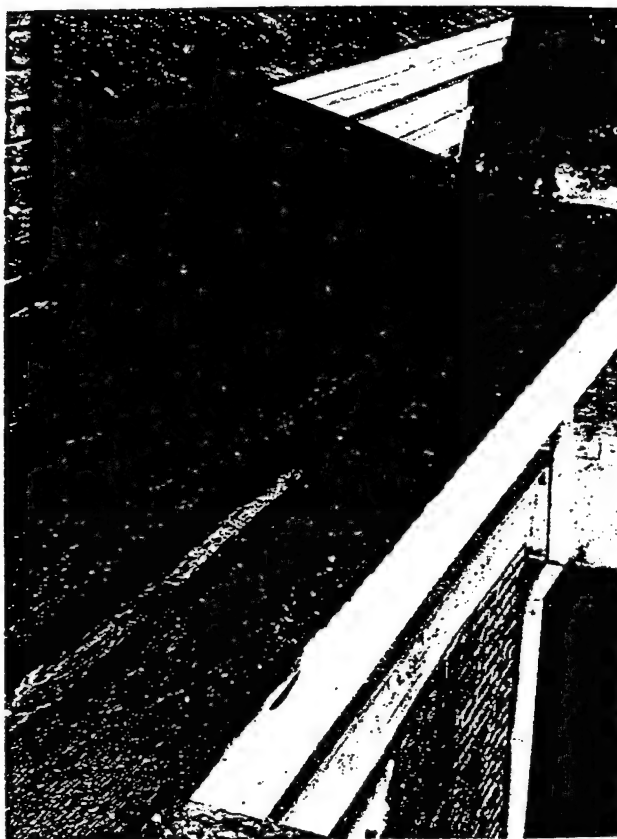
*Repeated repair with asphalt, which cracks as it hardens, has created a blistered surface on this sheet-metal roof and built-in gutter, which will retain water. Repairs could be made by carefully heating and scraping the surface clean, repairing the holes in the metal with a flexible mastic compound or a metal patch, and coating the surface with a fibre paint. (Roane County Courthouse, Kingston, Tennessee, photo courtesy of Building Conservation Technology, Inc.)*

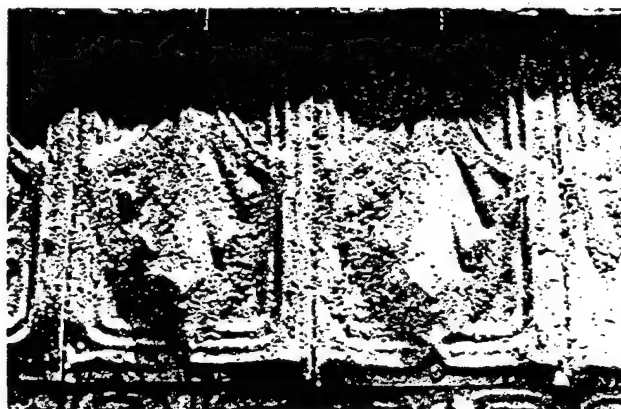
*Tin shingles, commonly embossed to imitate wood or tile, or with a decorative design, were popular as an inexpensive, textured roofing material. These shingles 8 $\frac{3}{8}$  inch by 12 $\frac{1}{2}$  inch on the exposed surface were designed with interlocking edges, but they have been repaired by surface nailing, which may cause future leakage. (Ballard House, Yorktown, Virginia, photo by Gordie Whittington, National Park Service)*

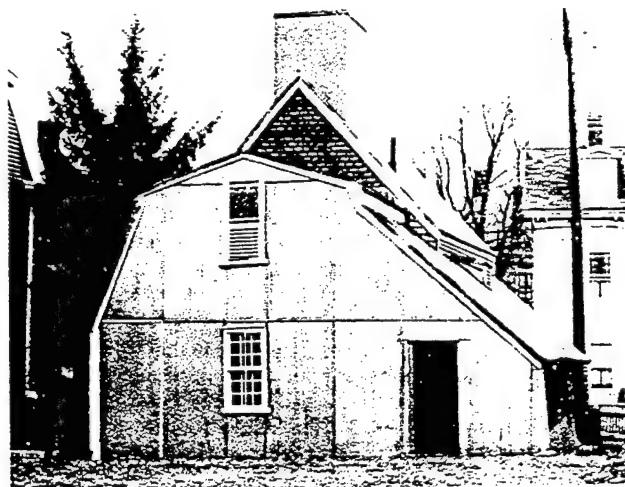
*Temporary stabilization or "mothballing" with materials such as plywood and building paper can protect the roof of a project until it can be properly repaired or replaced. (Narbonne House, Salem, Massachusetts)*

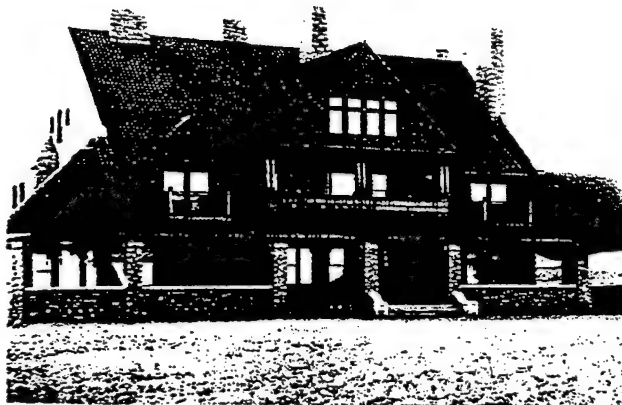
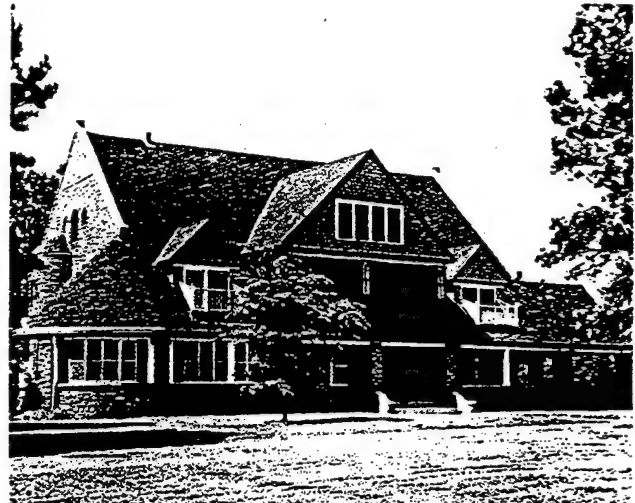
*These two views of the same house demonstrate how the use of a substitute material can drastically affect the overall character of a structure. The textural interest of the original tile roof was lost with the use of asphalt shingles. Recent preservation efforts are replacing the tile roof. (Frank House, Kearney, Nebraska, photo courtesy of the Nebraska State Historical Society, Lincoln, Nebraska)*

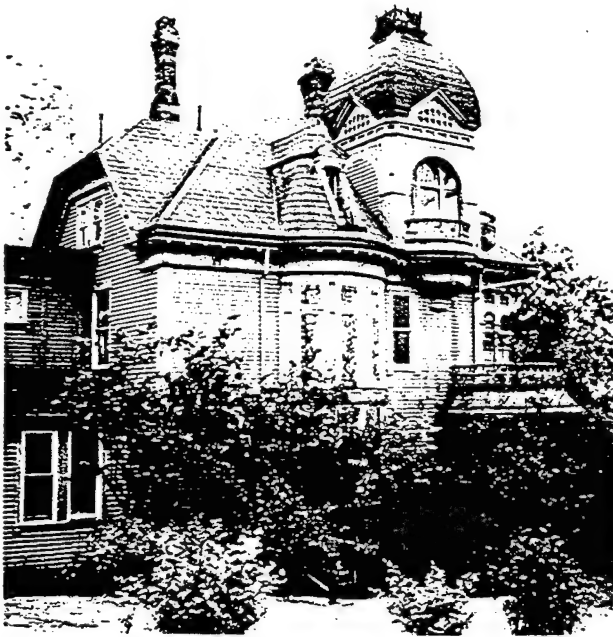
*Special problems inherent in the design of an elaborate historic roof can be controlled through the use of good materials and regular maintenance. The shape and detailing are essential elements of the building's historic character, and should not be modified, despite the use of alternative surface materials. (Gamwell House, Bellingham, Washington)*

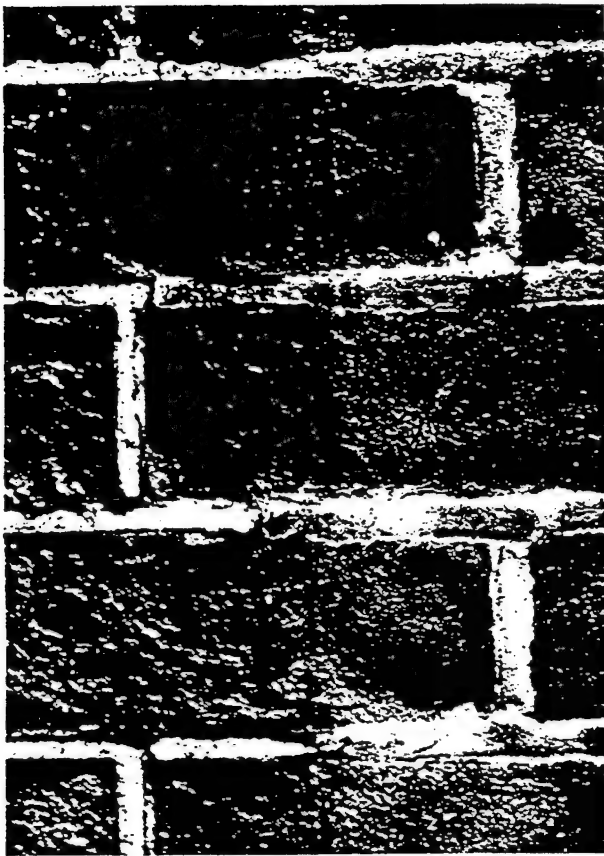
**Abrasively Cleaned vs. Untouched Brick.** Two brick rowhouses with a common façade provide an excellent point of comparison when only one of the houses has been sandblasted. It is clear that abrasive blasting, by removing the outer surface, has left the brickwork on the left rough and pitted, while that on the right still exhibits an undamaged and relatively smooth surface. Note that the abrasive cleaning has also removed a considerable portion of the mortar from the joints of the brick on the left side, which will require repointing.

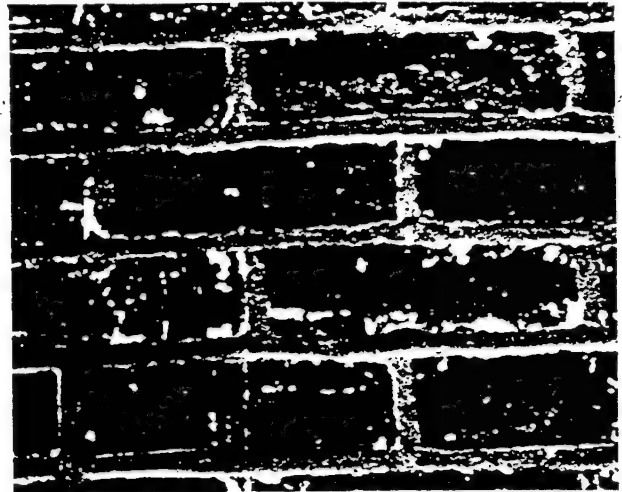
**Abrading the Surface without Removing the Paint.** Even though the entire outer surface layer of the brick has been sandblasted off, spots of paint still cling to the masonry. Sandblasting or other similarly abrasive methods are not always a successful means of removing paint.

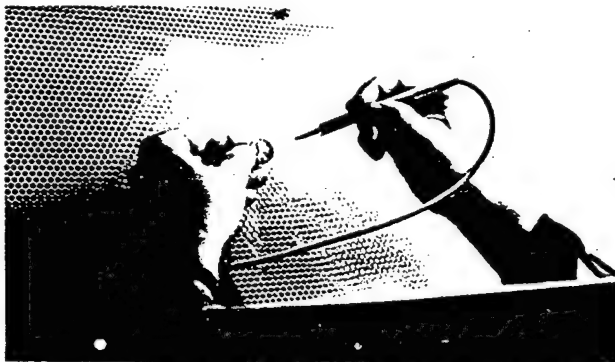
**Micro-Abrasive Cleaning.** This small, pencil-sized micro-abrasive unit is used by some museum conservators to clean small objects. This particular micro-abrasive unit is operated within the confines of a box (approximately 2 cubic feet of space), but a similar and slightly larger unit may be used for cleaning larger pieces of sculpture, or areas of architectural detailing on a building. Even a pressure cleaning unit this small is capable of eroding a surface, and must be carefully controlled.

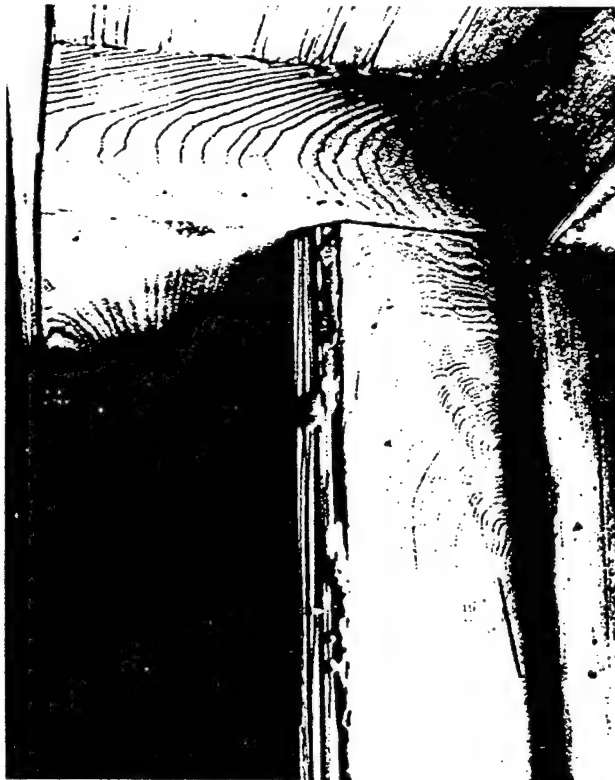
**Abrasive Cleaning of Wood.** This wooden windowsill, molding and paneling have been sandblasted to remove layers of paint in the rehabilitation of this commercial building. Not only is some paint still embedded in cracks and crevices of the woodwork, but more importantly, grit blasting has actually eroded the summer wood, in effect raising the grain, and resulting in a rough surface.

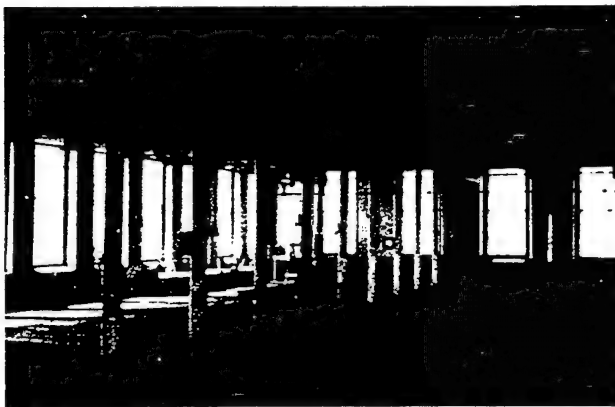
**Permissible Abrasive Cleaning.** In accordance with the Secretary of the Interior's Guidelines for Rehabilitation Projects, it may be acceptable to use abrasive techniques to clean an industrial interior space such as that illustrated here, because the masonry surfaces do not have significant design, detailing, tooling or finish, and the wooden architectural features are not finished, molded, beaded or worked by hand.

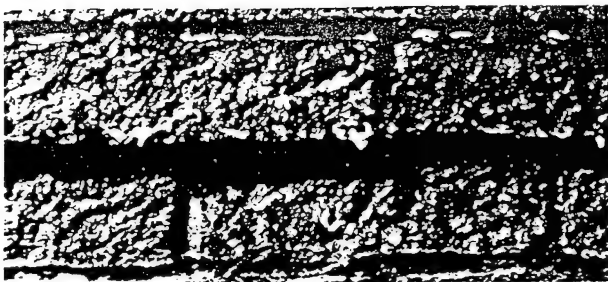
**Hazards of Sandblasting and Surface Coating.** In order to "protect" this heavily sandblasted brick, a clear surface coating or sealer was applied. Because the air temperature was too cold at the time of application, the sealer failed to dry properly, dripping in places, and giving the brick surface a cloudy appearance.

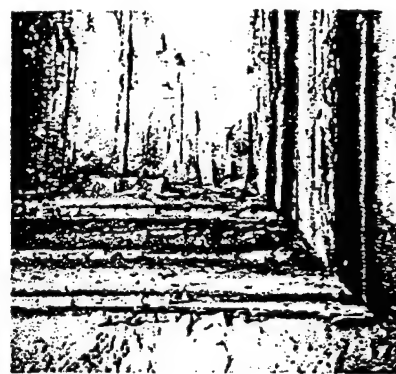
U.S. Department of the Interior National Park Service  
Preservation Assistance Division Technical Preservation Services

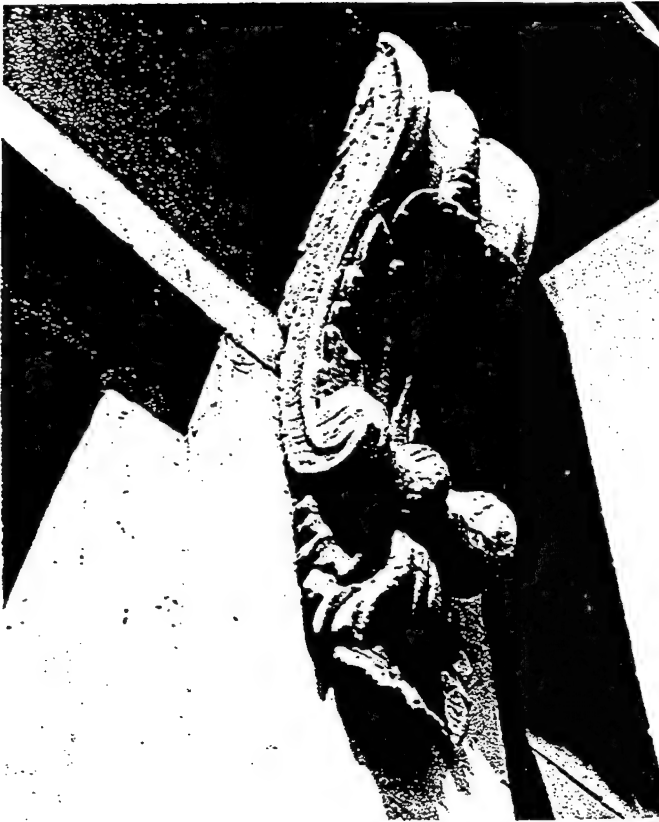
Fig. 1 Excessive paint build-up on architectural details such as this ornamental bracket does not in itself justify total paint removal. If paint is cracked and peeling down to bare wood, however, it should be removed using the gentlest means possible. Photo: David W. Look, AIA.

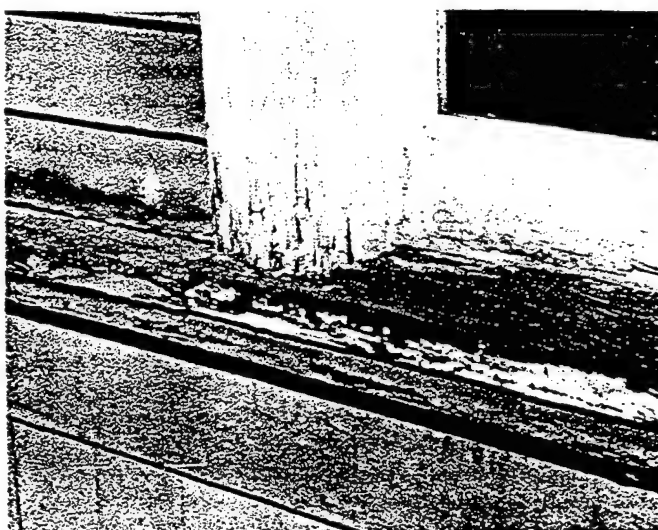
Staining of paint coatings usually results from excess

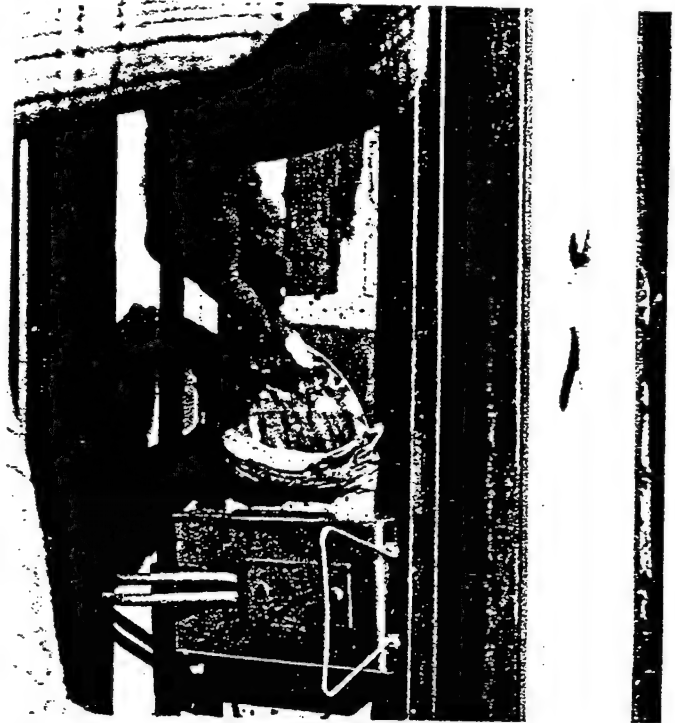
Fig. 13 The electric heat plate (with paint scraper) is particularly useful for removing paint down to bare wood on flat surfaces such as doors, window frames, and siding. After scraping, some light sanding will probably be necessary to smooth the surface prior to application of primer and top coats. Photo: David W. Look, AIA.

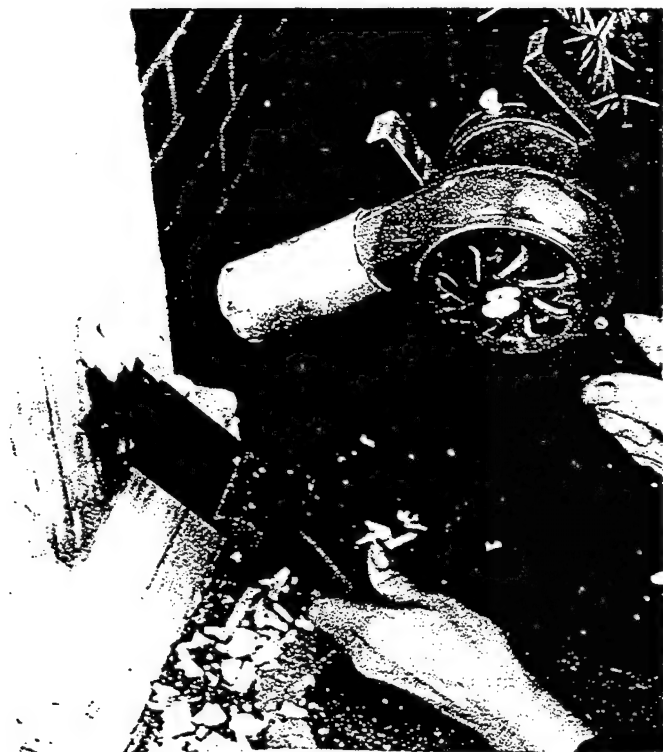
Fig. 14 The nozzle on the electric heat gun permits hot air to be aimed into cavities on solid decorative elements such as this applied column. After the paint has been sufficiently softened, it can be removed with a profiled scraper. Photo: Charles E. Fisher, III.

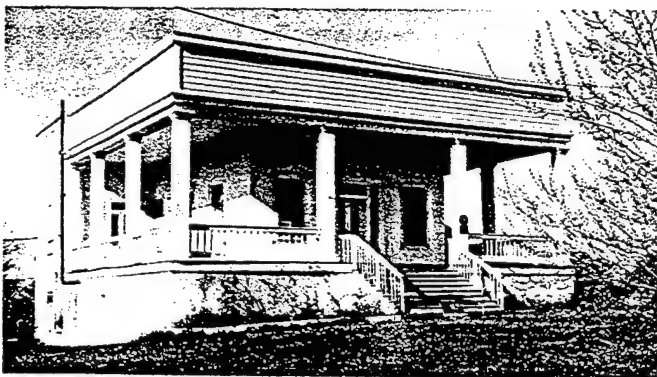
Fig. 2. Sebastopol House, Seguin, Texas (1856). This Greek Revival dwelling is one of the few remaining poured-in-place concrete structures in this Texas town noted for its construction of over 90 concrete buildings in the mid-nineteenth century. The high parapets surrounding the flat roof were lined and served as a water reservoir to cool the house. Photo: Texas Historical Commission.

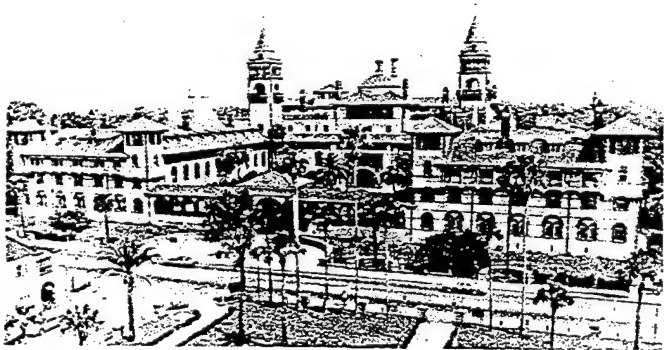
Fig. 3. Ponce de Leon Hotel, St. Augustine, Florida (1885-87). An example of unreinforced concrete used on a grand scale, this Spanish Colonial Revival hotel was designed by Carrere and Hastings and commissioned by railroad magnate Henry Flagler. The building now serves as the main campus hall for Flagler College. Photo: Flagler College.

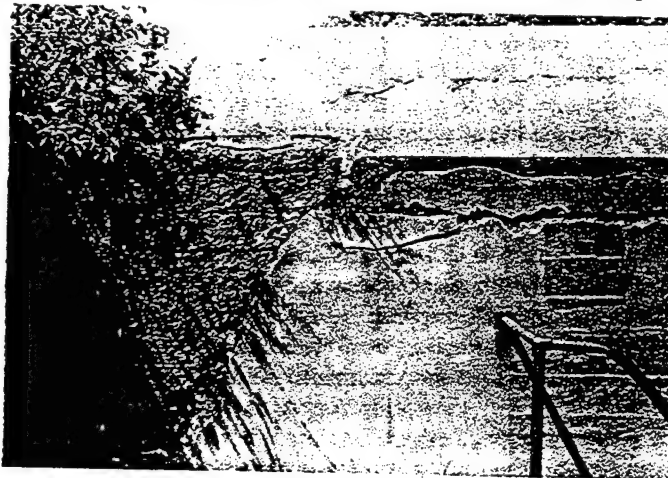
Fig. 6. Battery Fortifications, Ft. Washington, Maryland (1891-97). This unreinforced concrete fortification exhibits several kinds of deterioration: the diagonal structural crack due to uneven settlement, the long horizontal crack at the cold joint, the spalling of the concrete surface coating, and vegetative growth. Photo: Sharon C. Park, AIA.

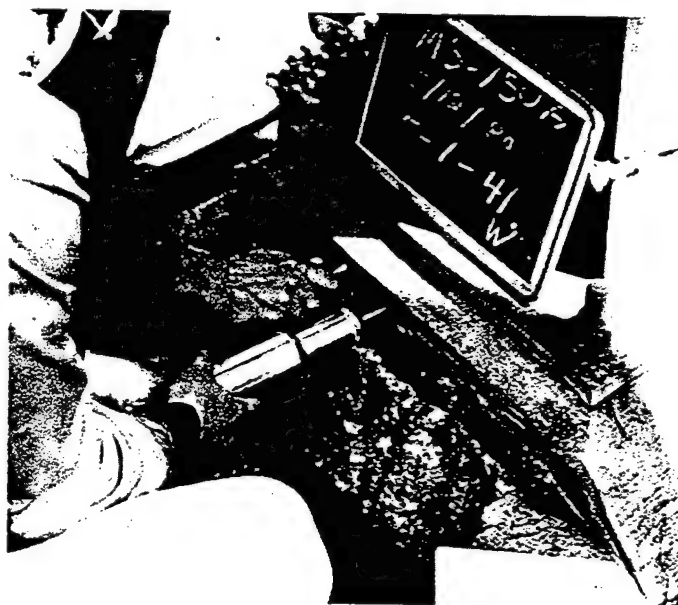
Fig. 9. Nondestructive sonic tests are one way of determining the location and soundness of internal reinforcing bars and the hardness of the concrete. There are a variety of other nondestructive tests provided by professional consultants that will help in the evaluation of the structural integrity of concrete prior to major repair work. Photo: Feld, Kaminetzky and Cohen and American Concrete Institute.

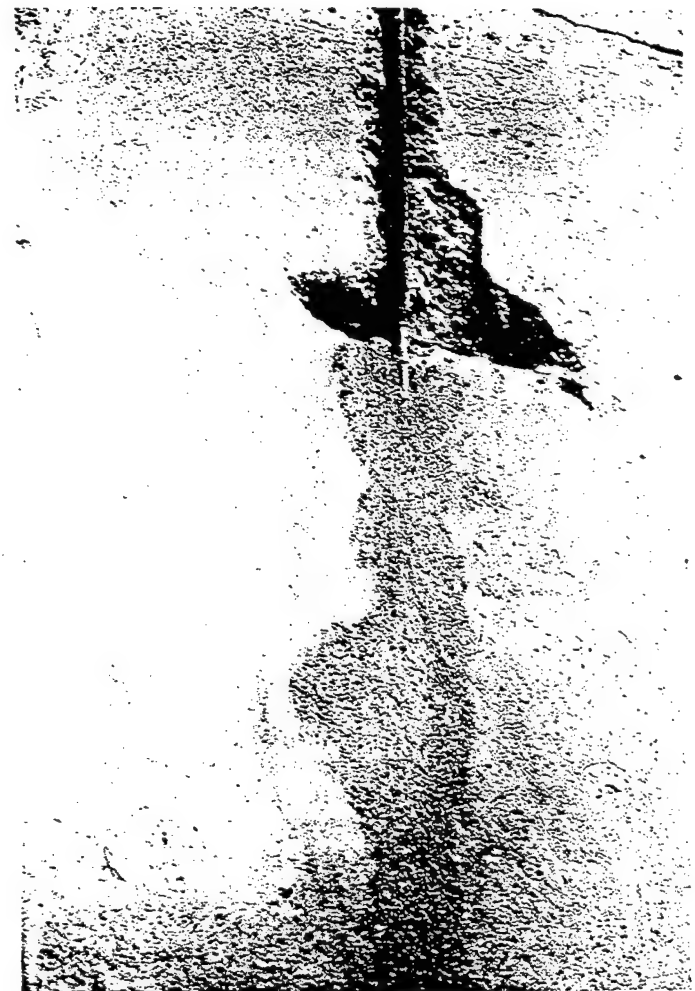
Fig. 12. Without proper preparation and correction of a pre-existing problem, repairs will fail. Insufficient concrete at the surface caused this patch around a reinforcing bar to fail within a year. In this case, a structural engineer should have assessed the need for this rod so close to the surface. Redundant rods are often cut out prior to patching. Photo: Alonzo White.

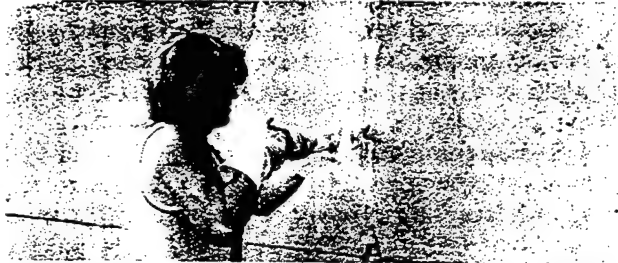
Fig. 13c. Narrow cracks often need to be widened to receive concrete patches. Here a pneumatic chisel is being used.

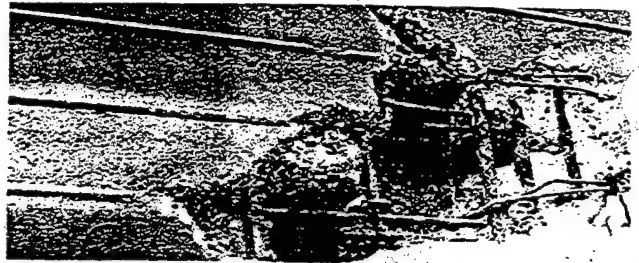
Fig. 13b. Upon removal of the deteriorated surface, a pocket of poorly mixed concrete (mostly sand and gravel) was easily chiseled out. The reinforcing rods were in good condition.

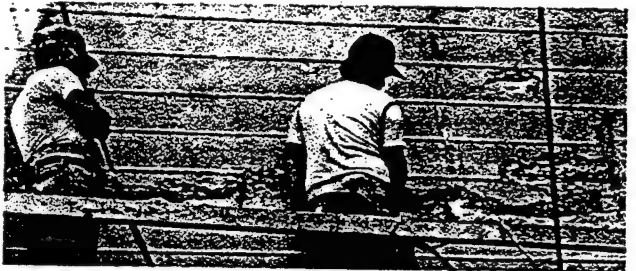
Fig. 13d. Deteriorated or redundant reinforcing bars are removed after evaluation by a structural engineer. An acetylene torch is being used to cut out the bars.

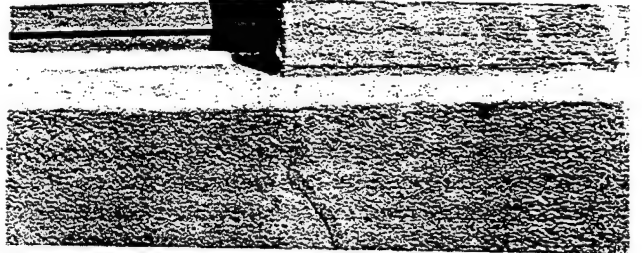
Fig. 13h. This active crack at a window sill and in the foundation wall has been filled with a flexible sealant. This area was subsequently painted with a masonry paint compatible with the sealant.

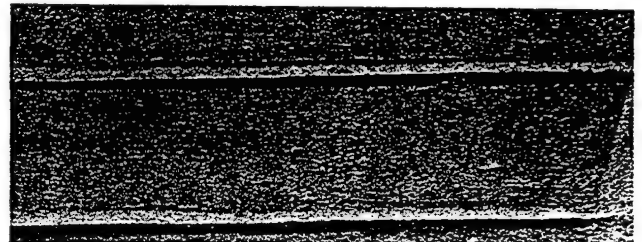
Fig. 13i. Upon completion of all repairs, the building was painted. The finished repair of the deterioration seen in 13a and b is shown in this photograph. The patch matches the texture and detailing of the historic concrete.

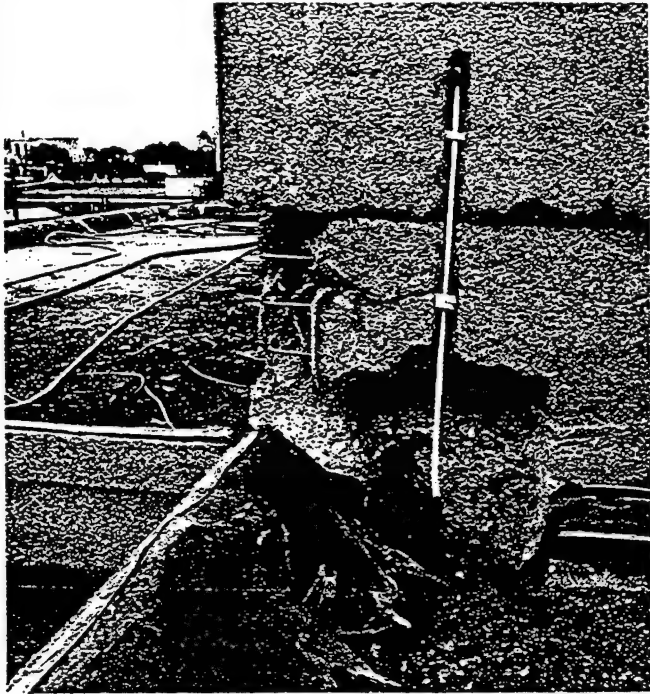
Fig. 14a. Spalled concrete was most noticeable at locations of concentrated rebars. Deteriorated concrete, the 1960s stucco finish, and corrosion were removed by grit-blasting. Photo: Robert Bell.

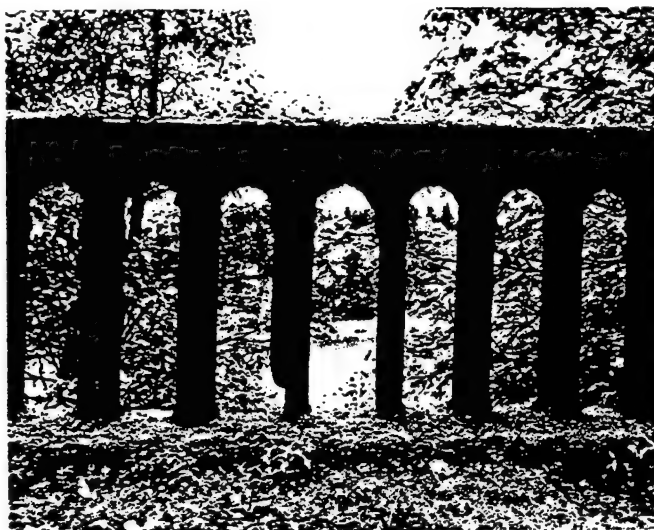
*Fig. 15a. The spindle-type railings were deteriorated beyond repair. The concrete was cracked or broken and the center reinforcing rods were exposed and badly rusted.*

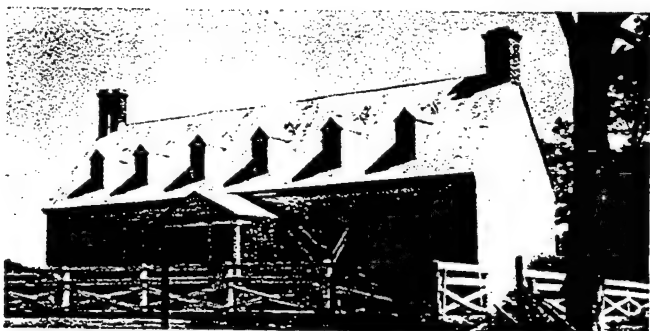
**Overall Visual Character: Roof and Related Features**

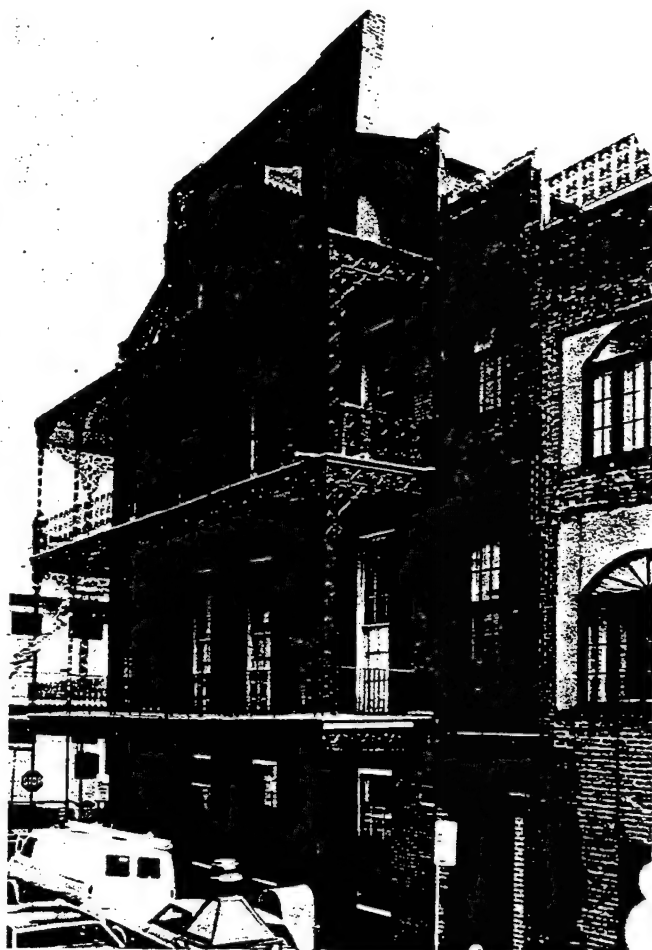
**Overall Visual Character: Projections**

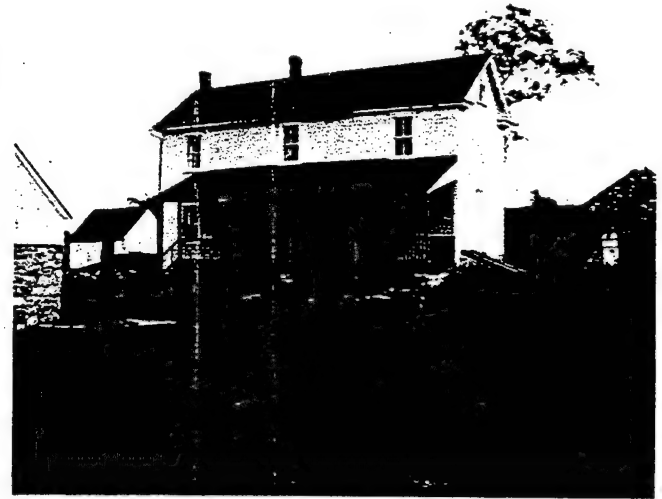
#### ***Overall Visual Character: Projections***

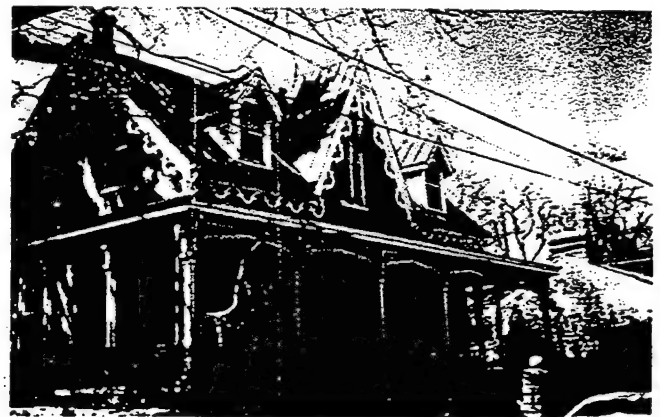
#### ***Overall Visual Character: Trim***

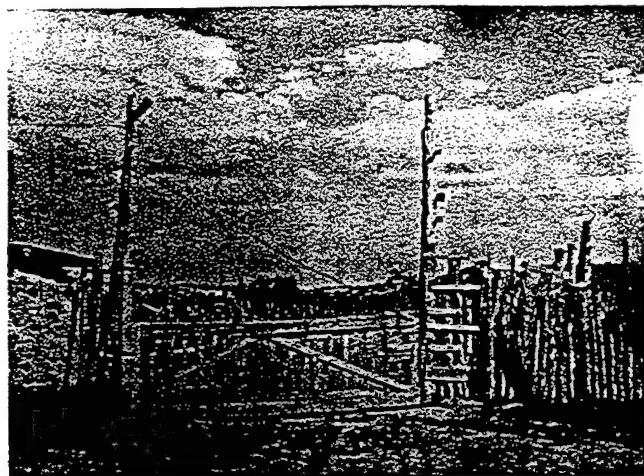
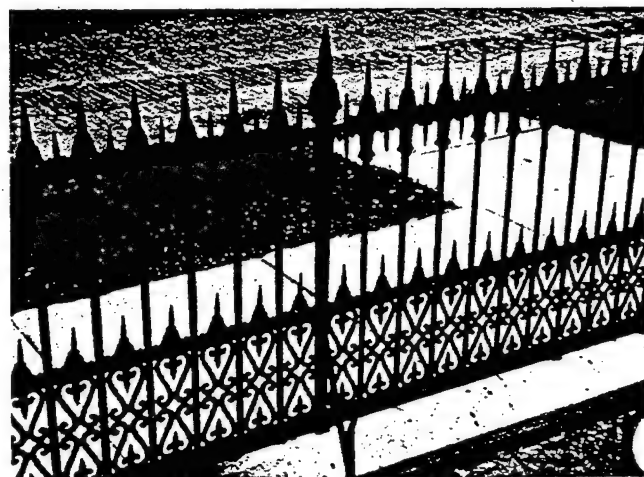
#### ***Overall Visual Character: Setting***

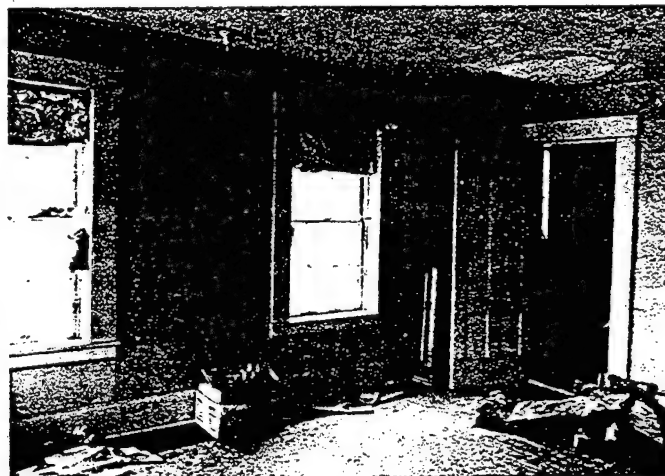
Figure 5. The interior of a simply detailed worker's house of the 19th century may be as important historically as the richly ornamented interior seen in figure 1. Although the interior of this house has not been properly maintained, the wide baseboards, flat window trim, and four-panel door are characteristic of workers' housing during this period and deserve retention during rehabilitation.

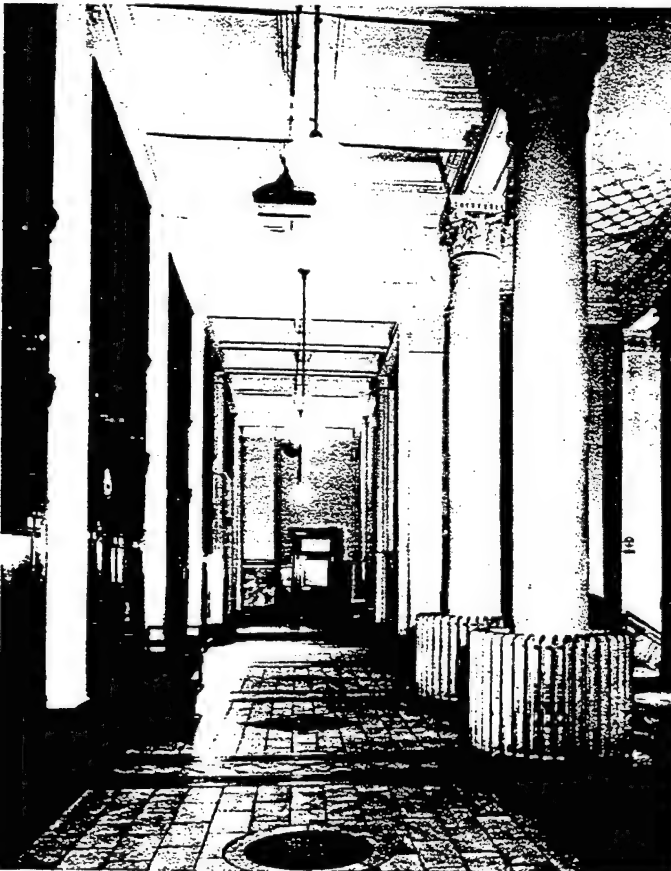
Figure 9. The tangible reminders of early mechanical systems can be worth saving. In this example, in the Old Post Office in Washington, D.C., radiators encircle Corinthian columns in a decorative manner. Note, too, the period light fixtures. These features were retained when the building was rehabilitated as retail and office space. Photo: Historic American Buildings Survey

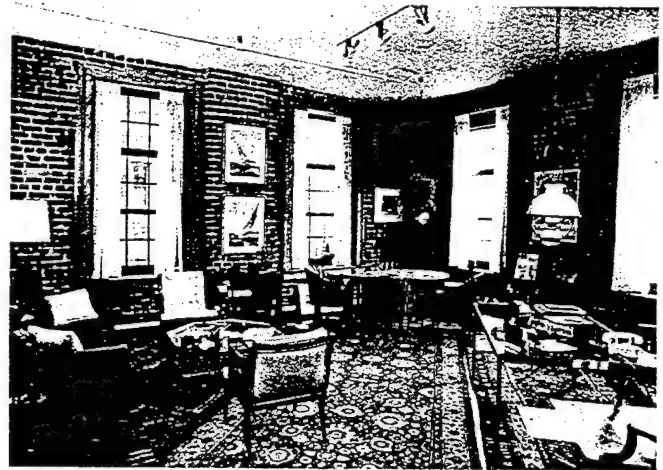
Figure 10. In this case plaster has been removed from perimeter walls, leaving brick exposed. In removing finishes from historic masonry walls, not only is there a loss of historic finish, but raw, unfinished walls are exposed, giving the interior an appearance it never had. Here, the exposed brick is of poor quality and the mortar joints are wide and badly struck. Plaster should have been retained and repaired, as necessary.

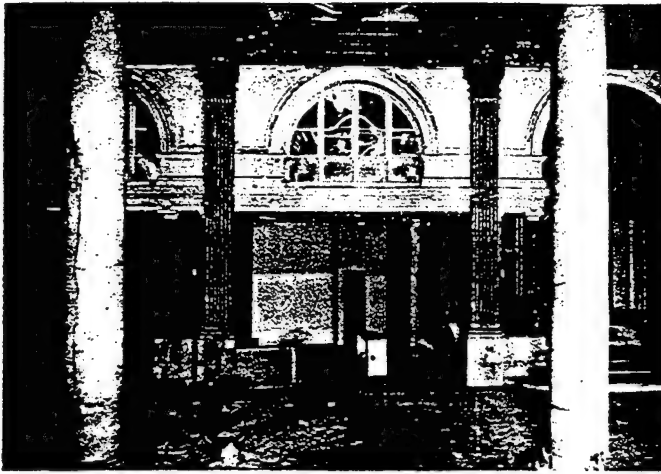
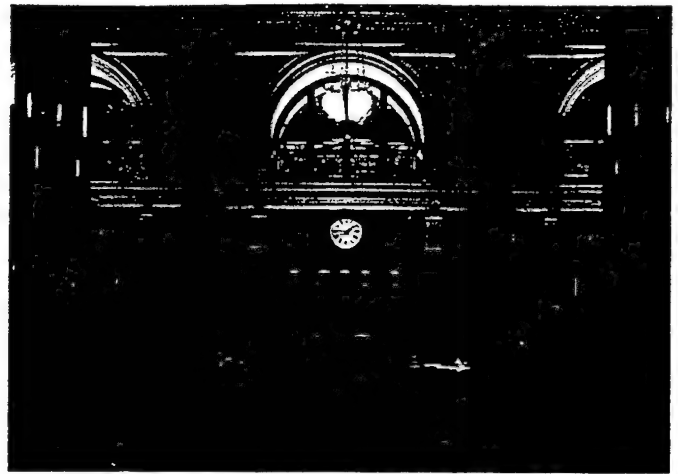
Figure 11. These dramatic "before" and "after" photographs show a severely deteriorated space restored to its original elegance: plaster has been repaired and painted, the scagliola columns have been restored to match marble using traditional craft techniques, and missing decorative metalwork has been re-installed in front of the windows. Although some reorganization of the space took place, notably the relocation of the front desk, the overall historic character of the space has been preserved. These views are of the lobby in the Willard Hotel, Washington, D.C. Credit: Commercial Photographers (left); Carol M. Highsmith (right)

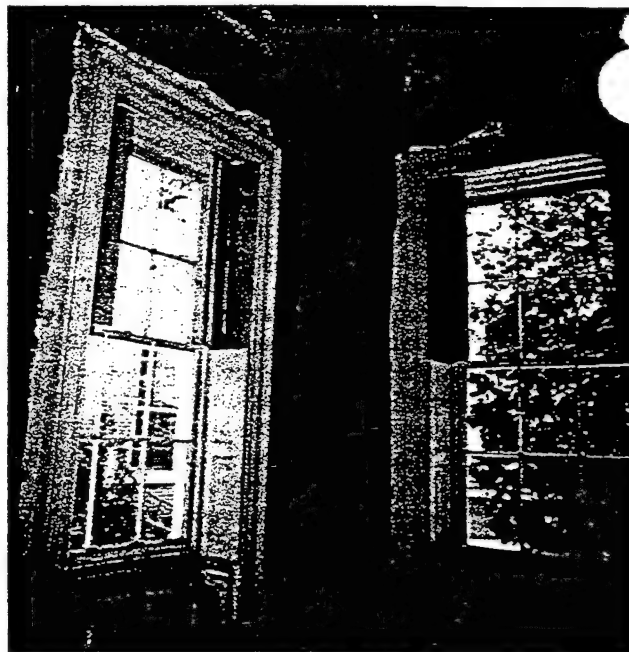
5. The installation of vapor retarders in walls of historic buildings in an effort to contain interior moisture can cause serious damage to historic finishes as shown here. In this example, all the wall plaster and lath have been stripped in preparation for a vapor barrier prior to replastering. Controlling interior temperature and relative humidity can be more effective than adding insulation and vapor barriers to historic perimeter walls. Photo: Ernest A. Conrad, P.E.
